Life Réhabilitation fonctionnelle des tourbières  
du massif jurassien franc-comtois  
LIFE13 NAT/FR/762 - 2014 / 2021

# Collection of experiences

## Functional restoration of peatlands in the Jura massif

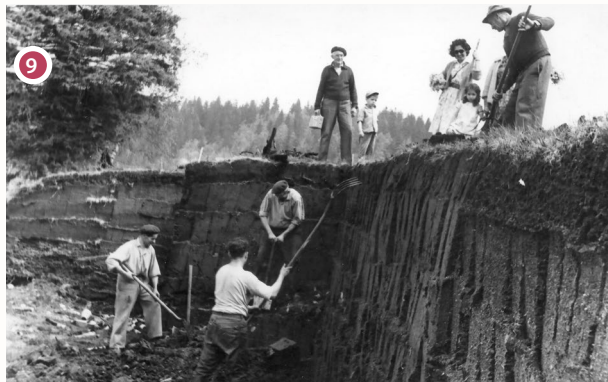
Extracting peat at La Pesse (Jura)

This extraction mainly took place between the 17th century and the early 20th century, to make up for the depletion of wood resources. Although locally this practice led to a diversification and regeneration of some peaty environments, often the consequence was serious and lasting damage to the sites due to the drying out that it causes.

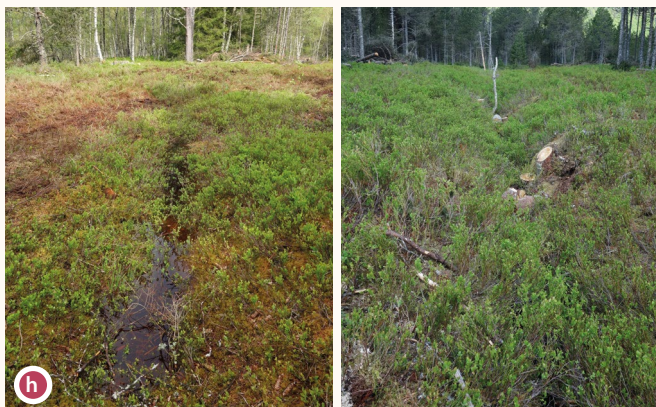
*Footprint of a ditch hidden by bilberry bushes, which became visible again when its water supply was restored. Before the obliteration work, the depression was always dry and heavily masked by the vegetation (right-hand photo).*

Heath plants, which densely cover the ground, often mask these slight depressions. Without the help of the DTM, given the scale of the drainage network, a single approach to the terrain would have been extremely complicated and of limited effectiveness. The DTM also enabled the necessary linear dimensions of the works to be calculated quickly.

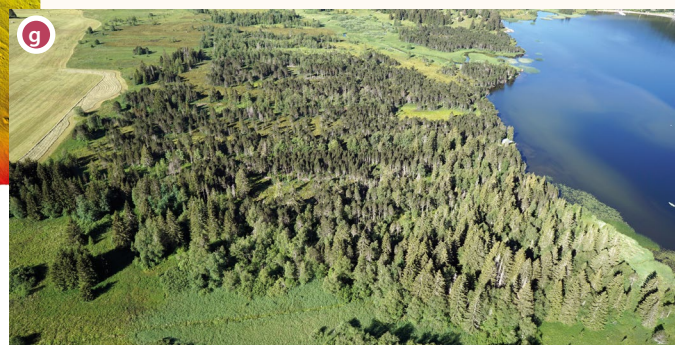
*In the peat bog, the ditches can be clearly seen on the DTM, whereas they are virtually invisible on the ground, especially in the pine woods.*

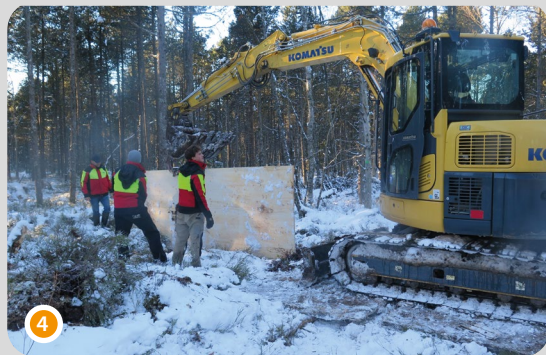
Installation of three-ply fence panels

To **neutralise the water flows in the drainage ditches** in the western sector, dams were installed: five fences made of timber planks (3) (110 m in total) and eight fences made of wooden panels (4).

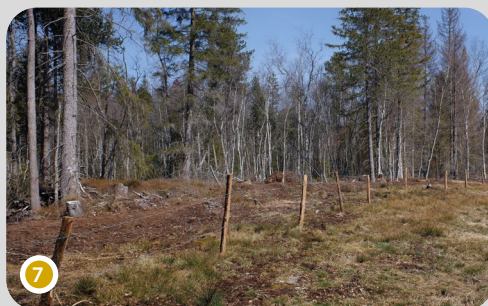
**Protective fencing** (7) was installed around the old peat extraction pits.

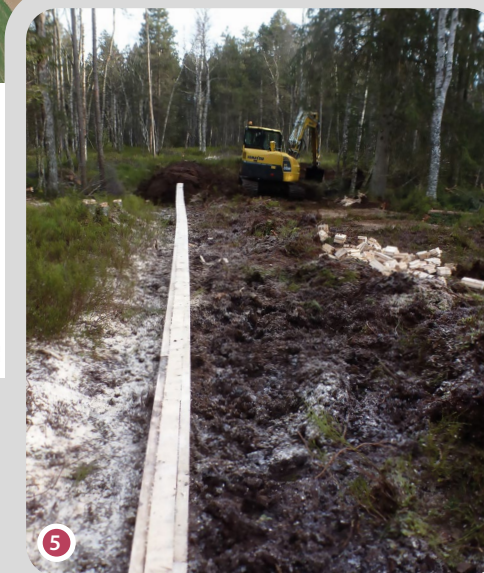
Covering of the timber plank fencing with peat and then vegetation

The **old peat extraction pits were closed off to maintain a water level favourable** to the resumption of peatification in the eastern sector: installation of four timber plank fences (5) (80 m in total) and two wood panel fences (6).

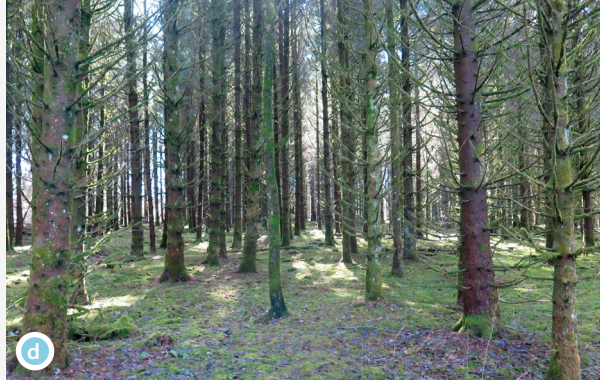
*View of the plantation before the works*

- under the spruce plantation **d**: the absence of any peat-forming vegetation, most of the surface being reduced to a carpet of needles, with the first few tens of centimetres of peat being marked by substantial mineralisation;
- in the rest of the extraction pit **e**: an increased presence of downy birch and purple moor grass, considerably more pronounced close to the ditches.

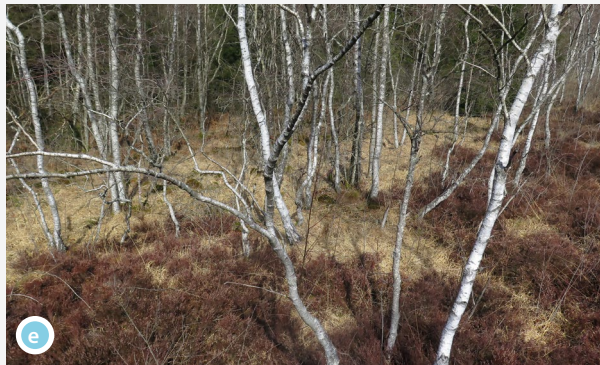
*Progression of the birch and purple moor grass within the drained part of the extraction zone (the spruce plantation can be seen in the background)*

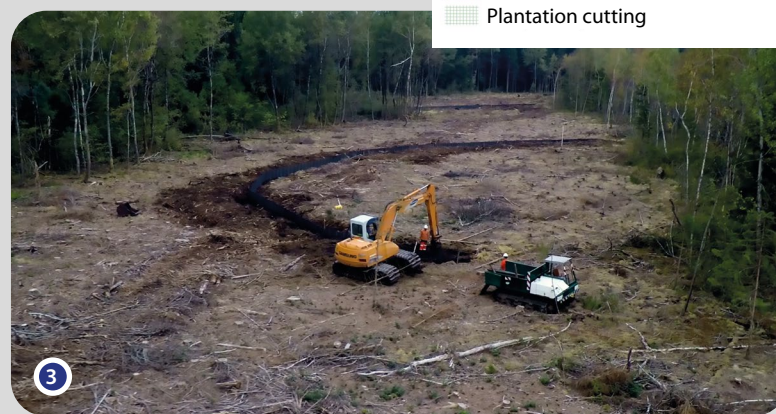
Dam no. 3 during construction

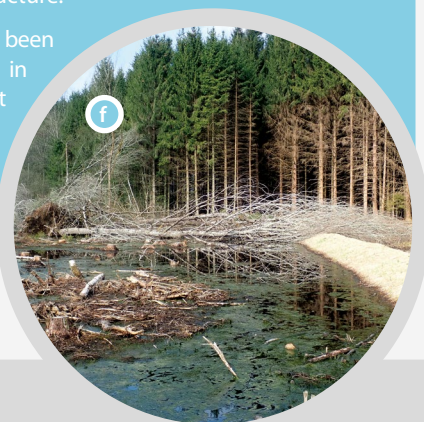
Result of inadequate tree clearance around dam no. 2 - fortunately no damage was caused to the dam

- ▶ **Clearing of woodland around the structures:** the clearing which had been conducted around the dams was found to be inadequate for certain structures

, in particular on the occasion of a tornado that caused a substantial windfall onto the peat bog, just one month after completion of the works. Other experiences in the LIFE programme have shown that any tree within the potential footprint of a structure should be eliminated whenever possible, as repairs after the works are always more complex.

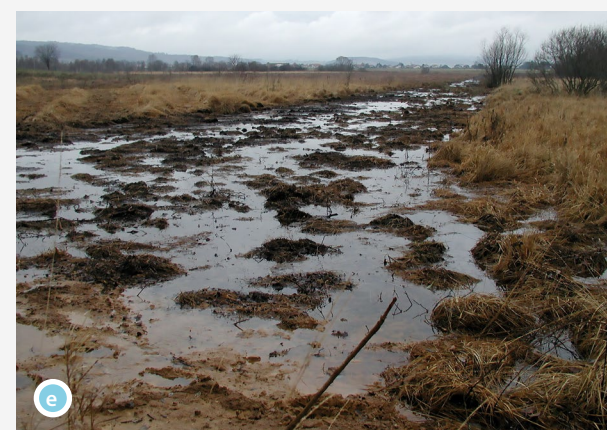
Infilling of the north outlet drain with marl and peat done in 2004

► The drainage ditch carrying the waters off the peatland to the north was totally and successfully blocked by marl dams and infilling with peat in 2004 (c e).

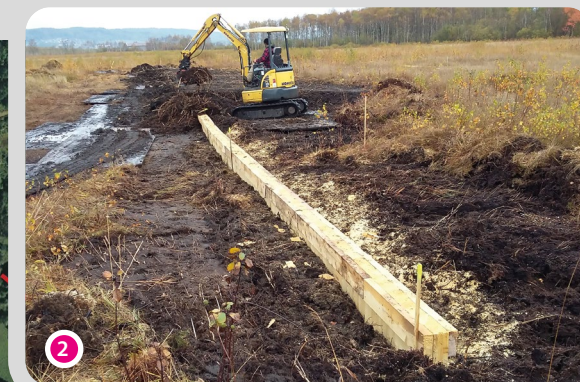
Covering a single wooden fencing dyke with peat. To avoid creating draining ruts in the ground, the excavator is working on plates

The five dykes in the upstream part (1 to 5) are **wooden fences** 63 to 125 m long, the purpose of which is to **keep and direct the water into the operational ditch** and take it over the old operational bank so that it can flow and spread northwards.

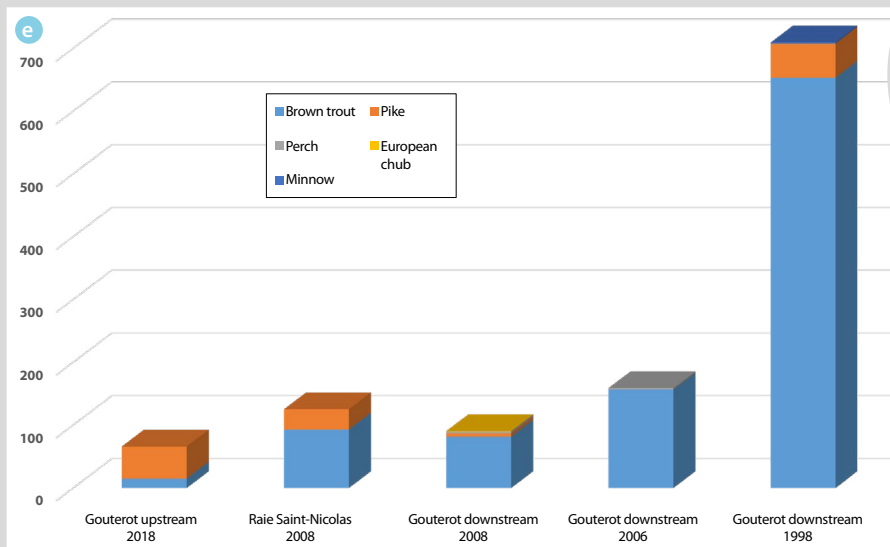
Comparison of the fish populations of the Gouterot and the Raie Saint-Nicolas from 1998 to 2008

- fish biomass between 20 kg/ha and 60 kg/ha in 2019 for the Gouterot. The Raie Saint-Nicolas (a tributary of the Gouterot) manages to produce 101 kg/ha, which remains very modest (the values observed in 1998 do not necessarily reflect the real populations as the Gouterot was managed as a nursery stream, it was used for massive fry rearing of trout intended to be moved afterwards);

An examination of the evolution of the fish populations <sup>e</sup> also shows that there was a gradual deterioration between 2001 and 2008, which is thought to be related to:

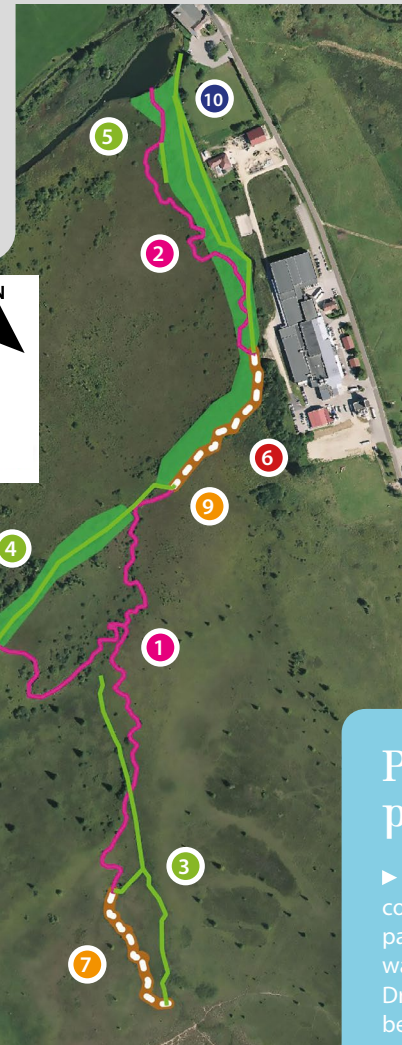
1 and 2 part of the works consisted **restoring the water to old meanders**.

3 to 5: the **straight course was completely filled in**, as were a whole series of old ditches that participated in draining the zone.

Map showing of the works carried out

The works also included the **alteration of an existing fish pass** on the Drugeon 6, near the Gouterot confluence.

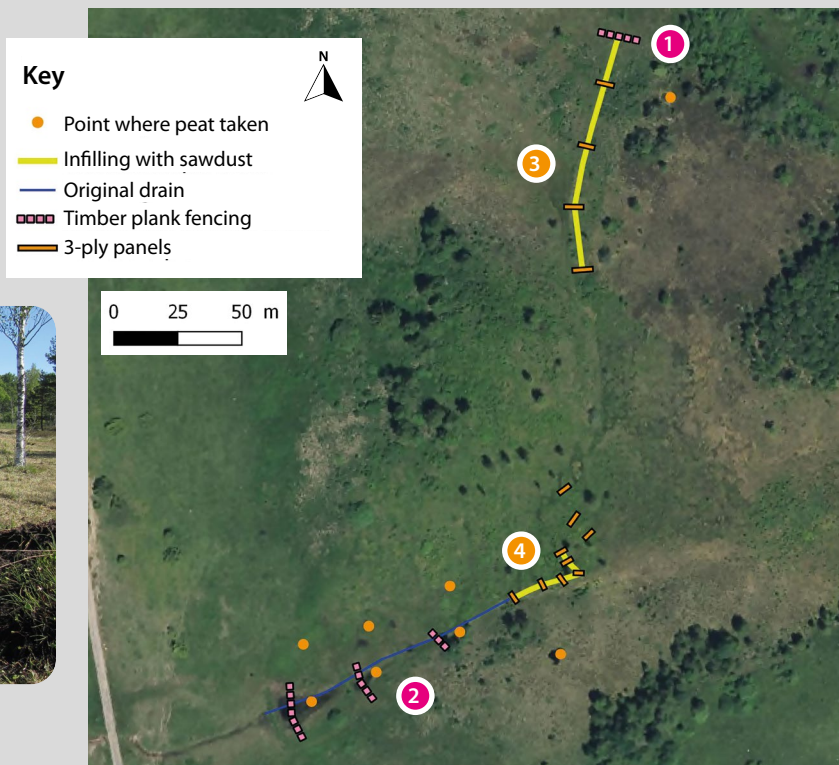
Plan of the work in the Levresses peat bog (2011)

**Four timber plank fences** were built in the areas where the spreading of the water was to be optimised, in order to raise the water level: **1** and **2**.

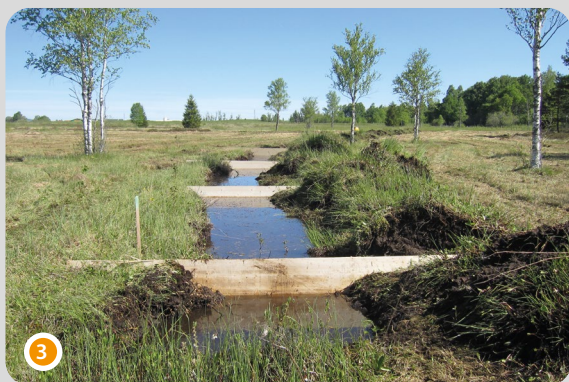
Step 1 in the ditch neutralisation: placing the wooden panels

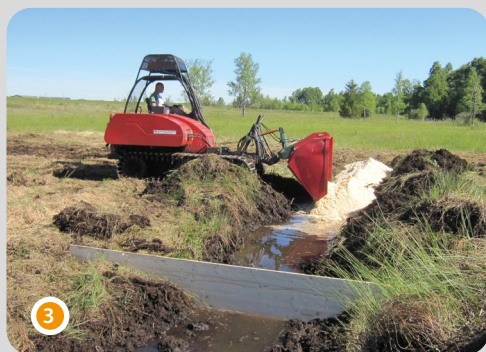
Step 2 in the ditch neutralisation: filling the channel with sawdust

Given the not very thick peat deposit and the high concentration of protected species, it was not possible to neutralise the ditch with peat cut on the site itself, hence the use of sawdust.

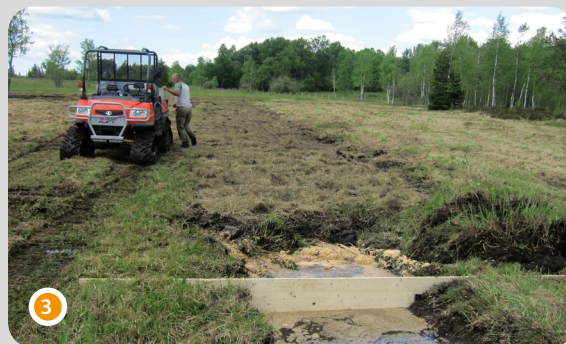
Step 3 in the ditch neutralisation: covering the sawdust with peat from the clearance of mineralised peat

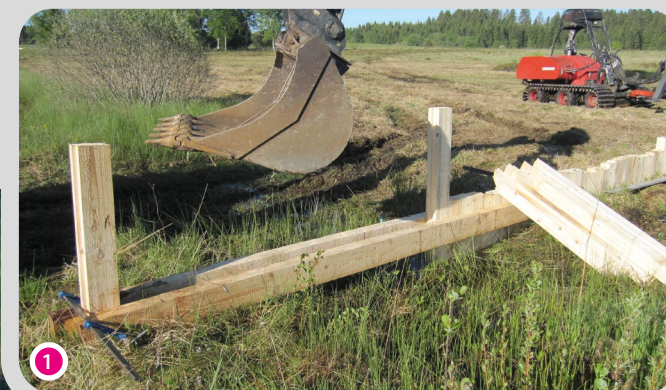
Installation of timber fences

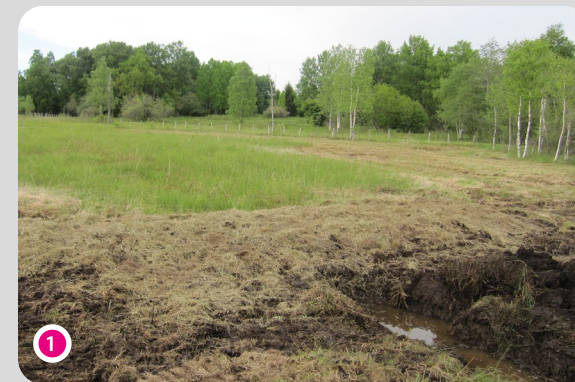
Upstream fence, covered with peat and straw

► **Fencing:** The last fence downstream was trampled by cattle, and the ridge of peat had to be redone. Since then, it has collapsed again, probably because the area where it was repaired was not sufficiently stabilised (two different qualities of peat). The structure has an overspill feature that reduces the retention of water upstream. All our fences are now enclosed by wire fencing and wooden posts, to keep animals away, which is all the more necessary as the dry years have led them to venture into the bog in search of water.

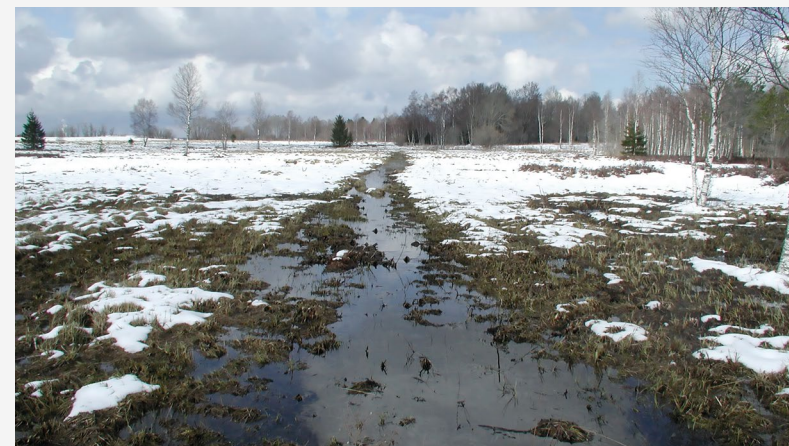
The central ditch before the works - 2004

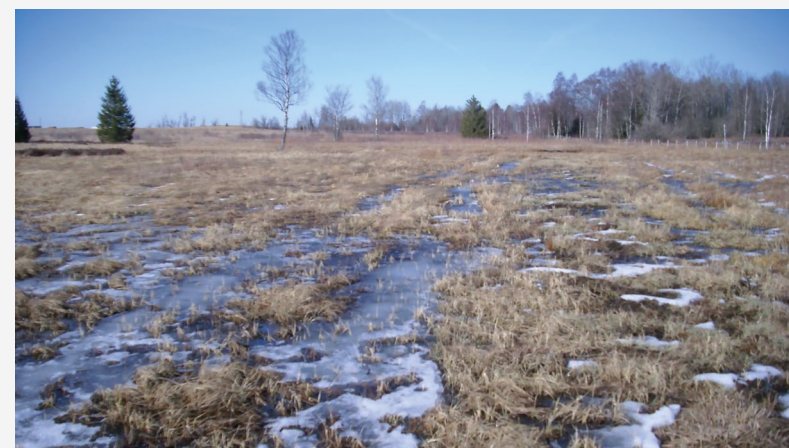
The bog under water after the works - February 2021

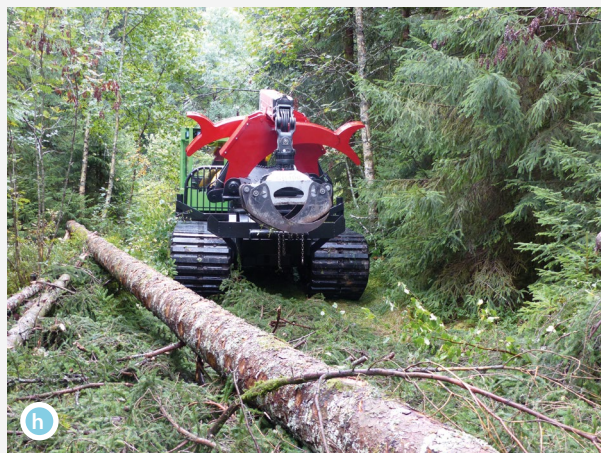
Removal of timber using an appropriate skidder

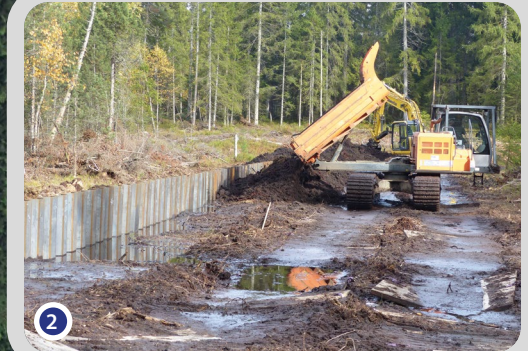
Metal topographical compensation dyke, covered with peat

- 2 To compensate for the subsidence of land surface due to drying out, a dyke was built in the area of where the watershed in the active peatland naturally emerged.

Given the presence of a thick layer of wood at the base of the peat, a **dyke made of steel sheet piles**, which are sharp-edged, was chosen so as not to push this wood into the substrate and risk impacting the watertightness of the substrate (making it porous).

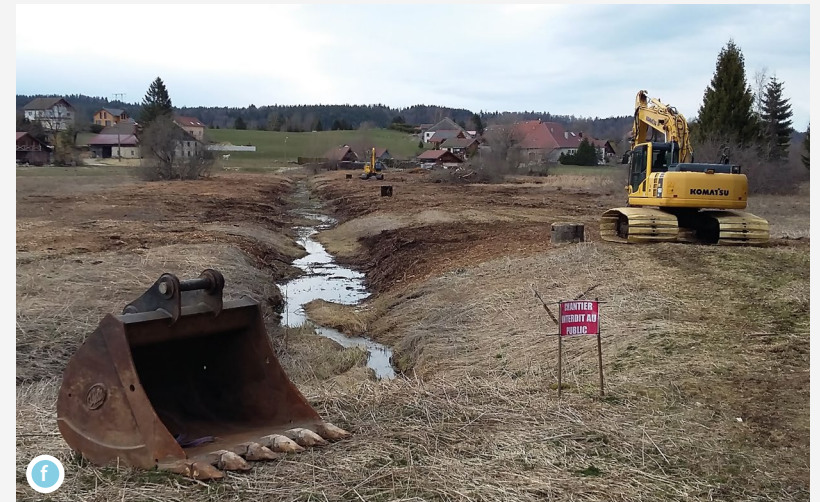
*Central ditch in the peatland to the south of the Lac de Malpas after shredding of the willow stand and before neutralisation*

The origin of the disturbance seems obvious once on the ground **c**: a central ditch 4 m wide and 2 m deep **f** cuts through the peatland from south to north draining the stream waters directly towards a losing stream whose natural elevation has been deliberately lowered. Several other smaller ditches were observed and seemed to be active.

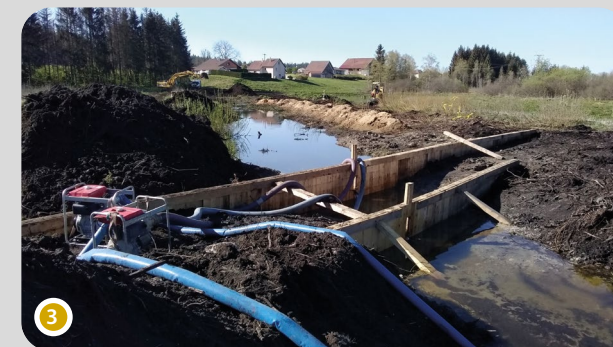
Construction of the double fence on the central ditch

- neutralisation of the central ditch 3:** total infilling upstream and partial downstream of the double fence with material collected following the removal of the top of the embankment of dredged material;
- neutralisation of the secondary ditches 4:** wooden panels or cutting of the top layer and constitution of embankments;
- neutralisation of losing stream protective structure 2 5** by constitution of a mineral dyke;
- cutting of the top layer of peat for re-spreading and redirecting the waters 6;**
- remeandering 8** of the downstream part of the Malpas stream.

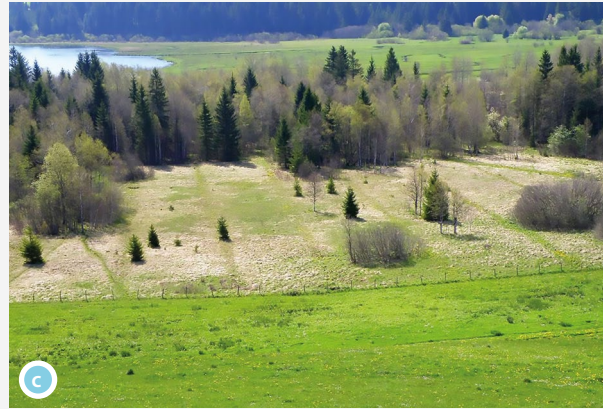
The 10 ditches visible due to the lines of *Caltha palustris* before the 2014 works

The analysis of the digital terrain model produced by LiDAR scanning of the peatland **b** clearly showed a network of ten parallel ditches in the fen zone accelerating the evacuation of the water towards a large feeder drain in the east. It is interesting to note that these ten ditches, almost invisible on the ground, actually become very visible at the beginning of the spring, when the marsh-marigold (*Caltha palustris*) comes into flower, evidence that there is flowing water **c**.

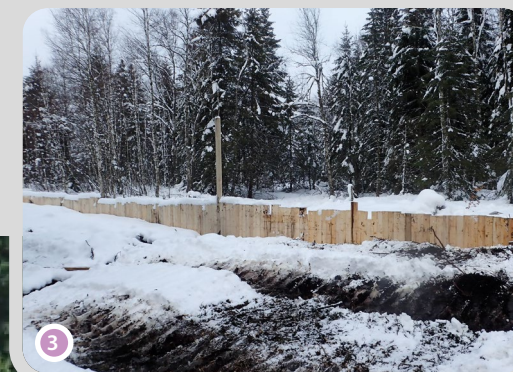
*Plan showing the works conducted as part of the restoration of the Crossat peatland*

**3 Timber plank fence** 30 m long, 3.50 m high. The structure was covered by peat extracted immediately downstream of it. It should be noted that the lacustrine enclosing bedrock is situated at a depth of 5.20 m.

**5 Arrangement of two 5-metre long wooden panels** to form a plug 8.50 m wide (1.50 m overlap) and 2 m high. The structure was covered by peat which was extracted nearby.

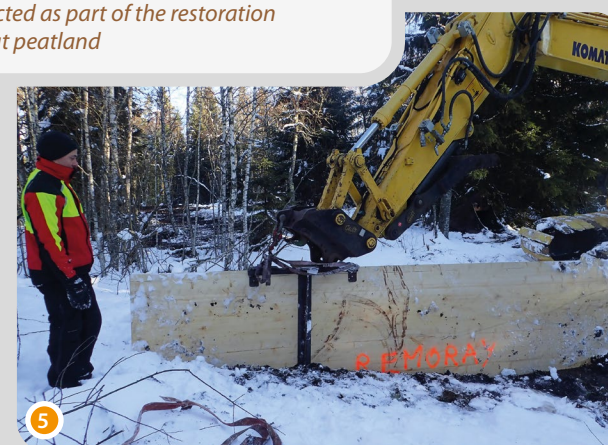
*Installation of wooden panels*

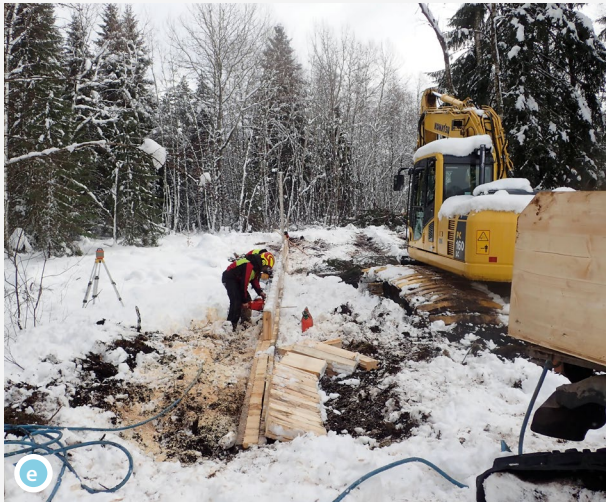
*Work being carried out in unfavourable weather conditions*

► **Hydrological and meteorological conditions unfavourable to the works:** the works were performed at the end of the autumn and beginning of the winter. During the works, snow and cold set in. Such conditions are far from favourable to the mobilisation of the quantities of peat needed to cover the structures. In addition, this was immediately followed by heavy rains. The non-stabilised peat quickly became saturated with water and “slipped down” the structures **e**.

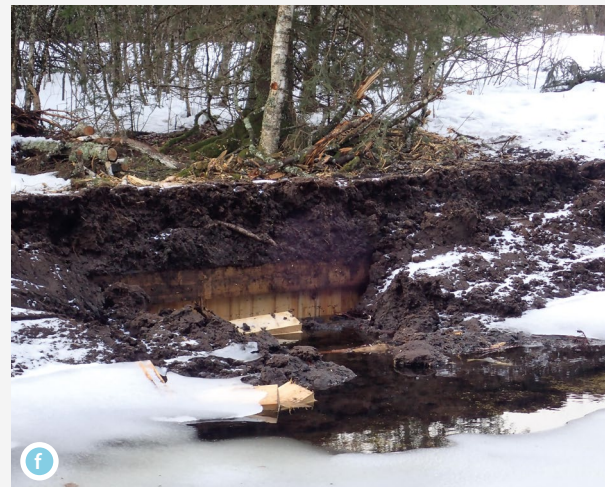
*The water passed underneath the fencing, which was not anchored in the watertight substrate, re-emerging by artesian flow at the weak point created by the hollow from where the peat was taken*

After the very rapid rewatering of the downstream pit, within a fortnight the water level had fallen again by about a metre. After analysing the situation, it was found that water had started to flow underneath the fencing, in the middle of the fence, re-appearing in the hollow from where the peat had been taken. The level upstream stabilised at the level of the downstream extraction hollow. The upstream hydraulic load, probably added to high hydraulic conductivity of the peat, is the most likely explanation for this dysfunction in the structures **f**.

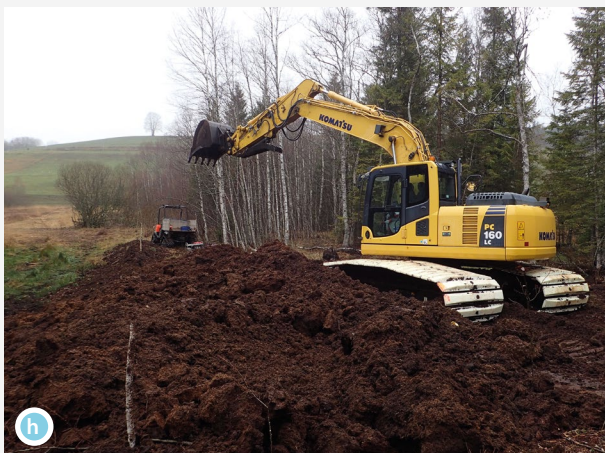
*Consolidation works at the end of November 2018*

The consolidation works took place at the end of November 2018 and were a great success **h**. From the first rains, the old extraction pit filled up with water.

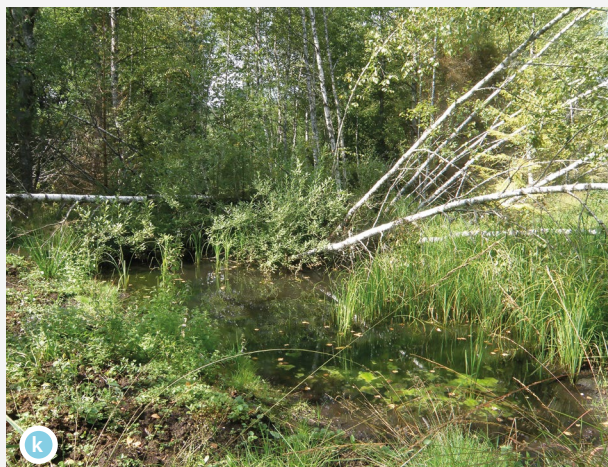
*Downstream structure after two seasons of vegetation  
September 2019*

► **Undersized downstream dyke:** the structure was not dimensioned to retain the unexpected flow of water that occurred due to the dysfunctions upstream (the water should have percolated sideways). The water circumvented the structure and very quickly caused some slight lateral erosion **i**.

**Solution found:** it was decided to extend the downstream panel structure using offcuts from the planks used for the upstream fence **j** and to cover them with a mound of peat so that they there would be no overflow onto the zones disturbed by the passage of vehicles/machinery. This small intervention turned out to be highly effective. Since then the structure has been blocking a large quantity of water and therefore rewetting a large area of peatland.

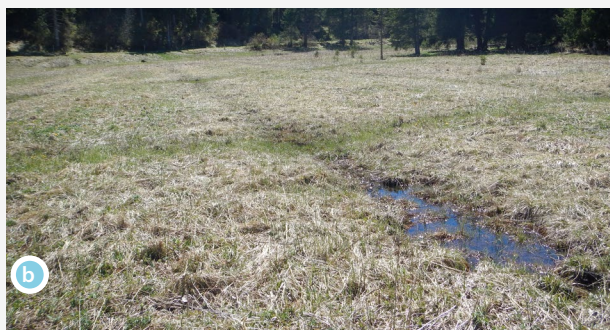
*Ditch before the works*

At the same time, the six ditches **b**, between them totalling a length of more than a kilometre, were drying out the entire northern fen. Complete infilling should mitigate this effect. However, in view of the past disturbances, the results will probably not be significant for some time.

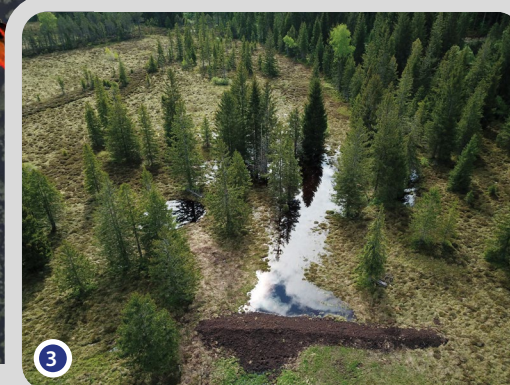
*The fence blocks off the ditch that was draining the extraction pit. A pond was created where the peat was taken (between the trees, on the left)*

**3 Obliteration of the ditch draining a peat extraction pit:** given the width of the pit, accentuated by the local mineralisation splaying the edges wider, this ditch was blocked off by a timber plank fence 25 metres long and two metres deep. It was covered by about 50 m<sup>3</sup> of peat taken from nearby sites.

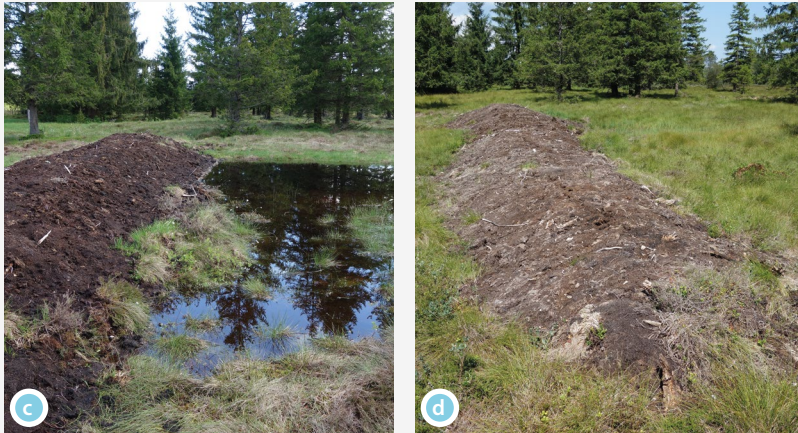
On the left, the pit rewetted in May 2018, totally empty in August, on the right

The ditch and the pit were rewetted the first time it rained **c**. However, they were empty again after about a month with no precipitation **d**. It seems that the contact zone with the underlying sand is sufficient to let the stock of water seep away. It is hoped that deposits of organic material will seal the sediment.

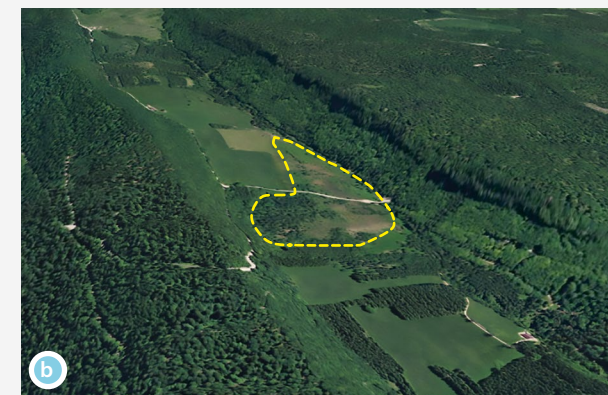
3D aerial view from the north of the Entrecôtes anticlinal valley. The road can clearly be seen (in white) crossing the peatland (outlined in yellow)

It is also crossed by about 150 metres of forest track b,

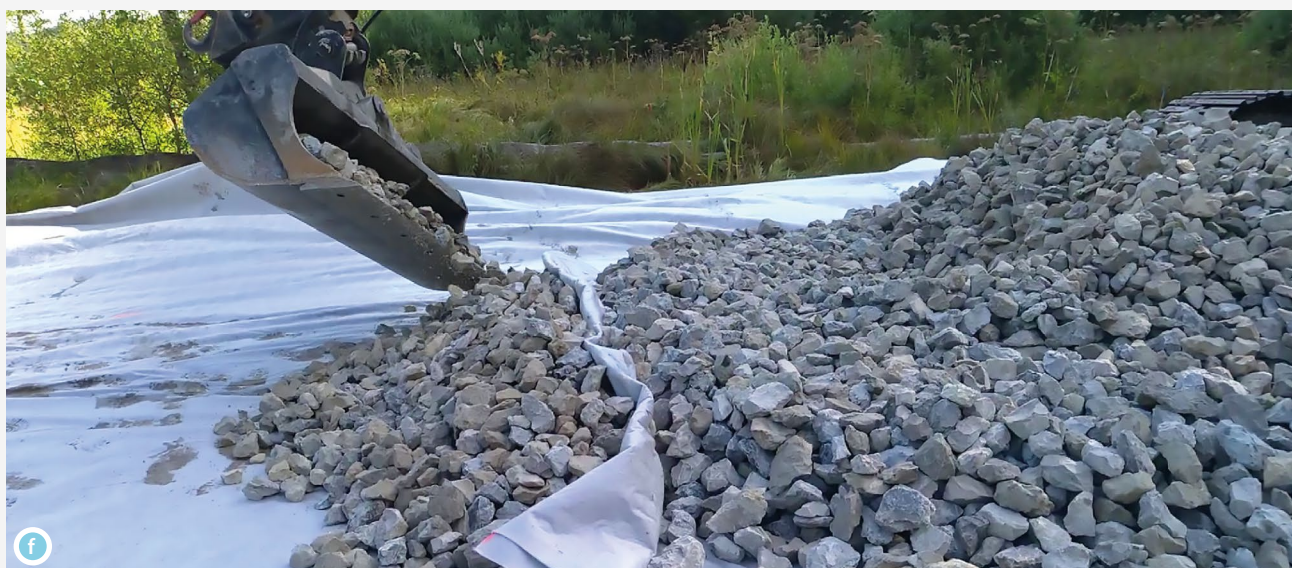
*Installation of a sheet of low-permeability geotextile. Embedded every five metres, these sheets prevent the water from circulating longitudinally in the filling material (limiting its draining effect) and direct it preferentially to the other side of the road, towards the downstream peat*

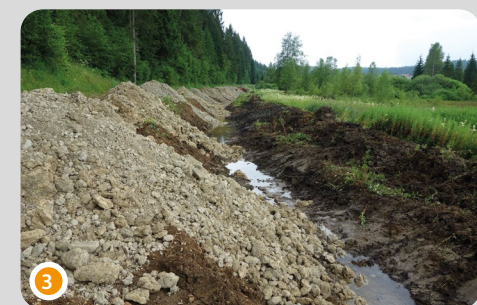
Moraine was chosen to fill in the south feeder drain as the volume involved was large, access was easy and the ditch was situated along the slope, therefore largely influenced by mineralised waters

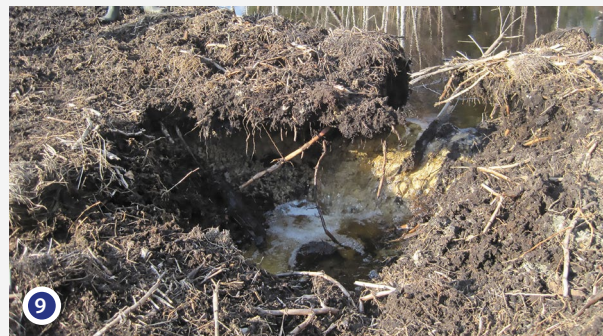
*The overspill on the dyke very quickly generates a breach by erosion*

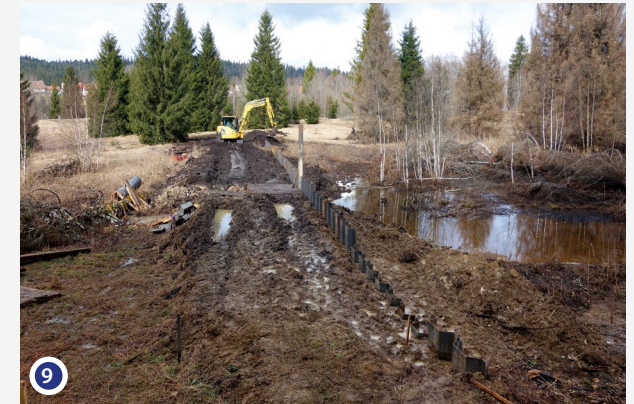
*Reinforcement of the dyke by installing a curtain of steel sheet piles. This would then be covered with peat and become vegetated.*

In March 2018, the dyke was reinforced with a 70-metre long steel fence, with a low point chosen and stabilised to allow a four-metre outflow, on the left bank, along the slope rather than onto the peat.

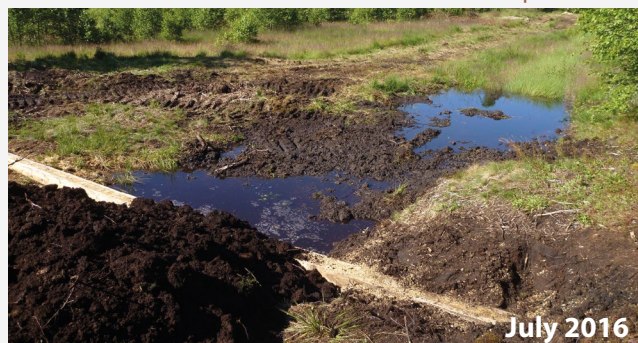
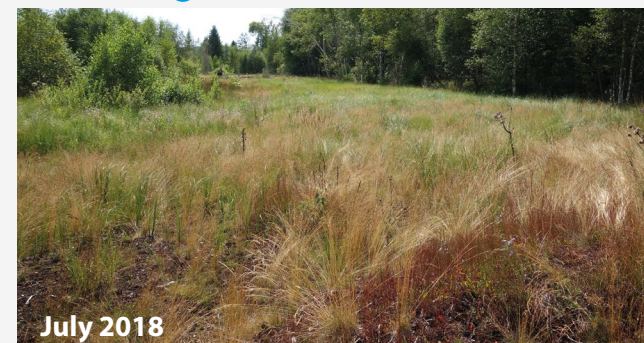
Complete obliteration of the ditch **6**

- ditches ④ and ⑤ were filled in entirely with peat taken on site, forming hollows 3 and 4 and reinforced by a three-ply wood panel structure;
- ditch ⑥, which was over 2.5 m wide and 2 m deep, was entirely filled with damaged peat taken from the ridges of peat from the cleaning out. The ends were reinforced by planks of spruce to ensure watertightness and solidity.

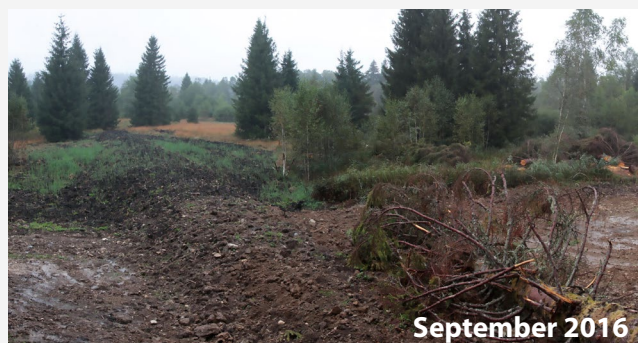
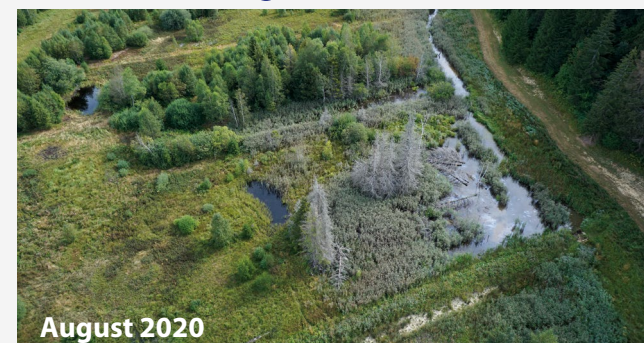
Water retained in the lower part of the peatland **9**

**Stabilisation of the water level in the peatland**, downstream, by creating a buried moraine dyke placed on top of the enclosing clay ⑨. The scale of this structure is such that in the long term it should restore the assumed pre-drainage water level and make up for the subsidence of the peatland, whose surface level has dropped due to erosion and the mineralisation of the peat.

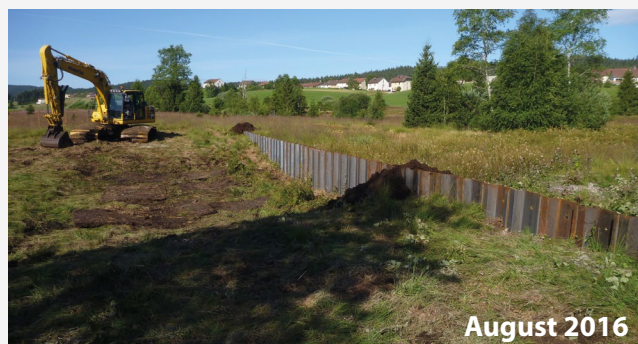
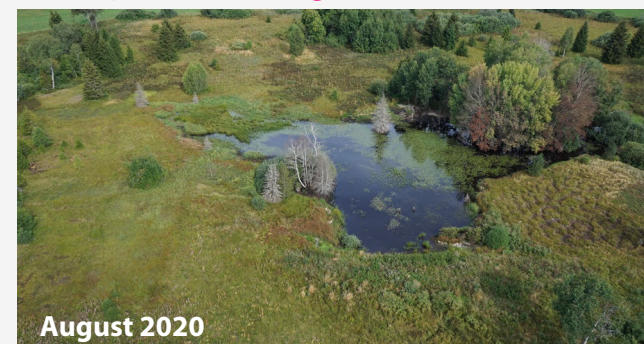
Rewetting of the old peat cutting pits by installing a fence **8**

- ⑧ by installing steel sheet piles, when the depth of the waters retained exceeded 1.5 m. The volume of covering material required was considerable. To make up for the lack of available peat, part of the material used came from morainal deposits and the final covering was done with peat taken from an old hummock on a “raised peat bog” or from hollow 10.
- ⑦ by installing a spruce planking fence, when the depth of the water retained was less than 1 m. The peat used to cover the fence was taken from nearby (hollow 2). The two dykes were covered with straw, actually hay harvested from the Combe du Nanchez fen to protect them from drying out too quickly and encourage revegetation.

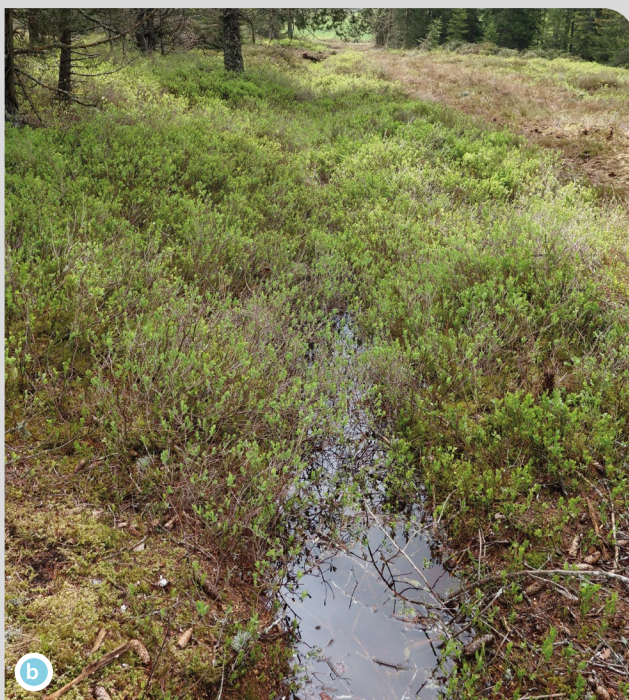
*Ditch rendered visible again when its water supply was restored. Before the obliteration work, the hollow was always dry and concealed by vegetation*

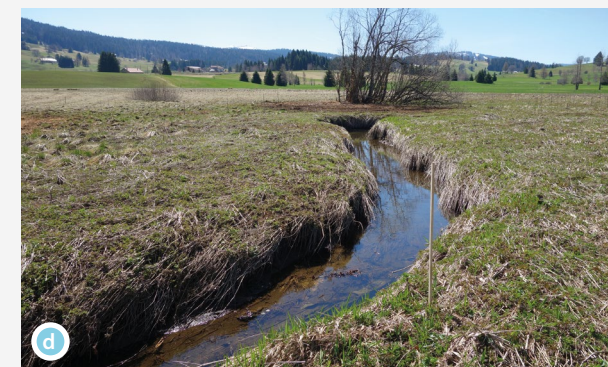
*Noir reach at low water, operating as a drain in the fen*

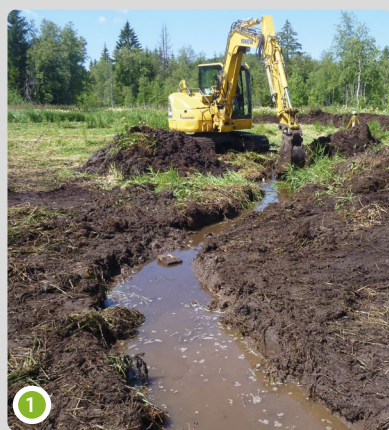
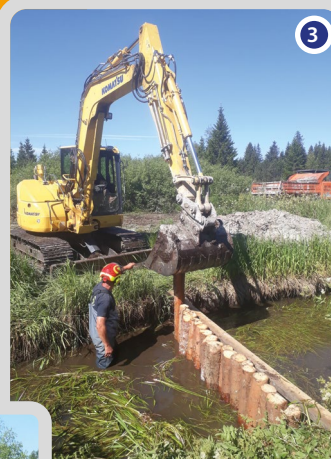
Peat extraction pit in a forest setting, revealed by the DTM.  
Obstruction by a fence placed on the outlet.

**4** Six peat extraction pits were rewetted by obliterating their outlets. Given the dimensions of the outlets and the nappe of water intended to be retained, it was decided to install **fences made of spruce planks**. These were anchored in the underlying lacustrine substrate, at a depth of 4 metres, and are 8 to 15 metres long.

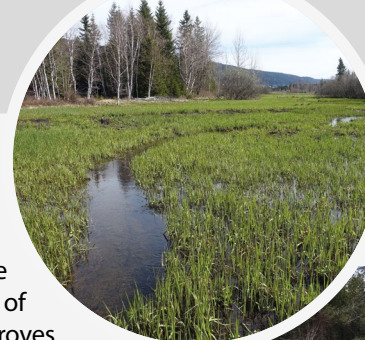
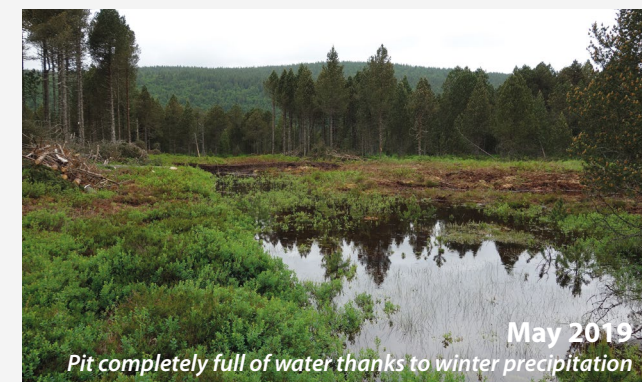
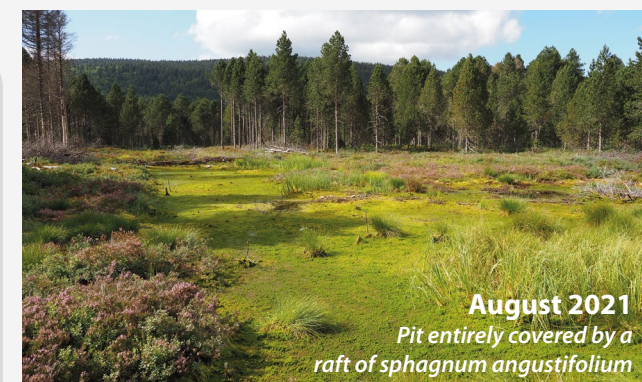
Evolution of a peat extraction pit after obliteration - Works done in May 2018

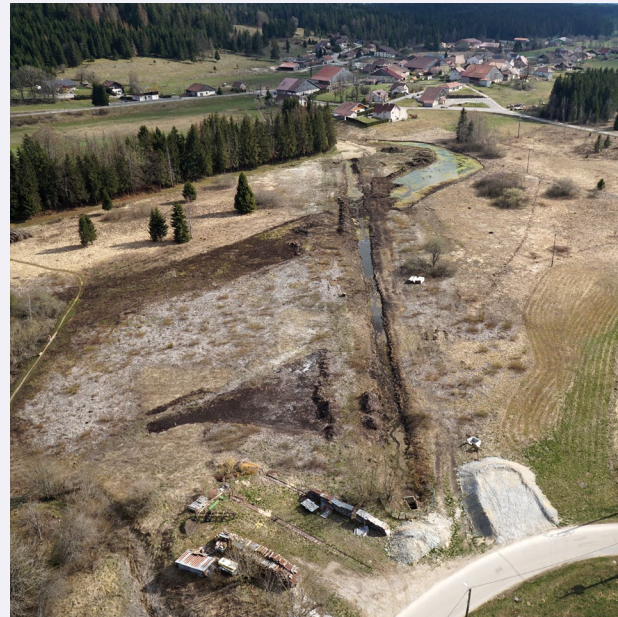
*neutralisation of the drainage ditch in the Lac de Malpas peatland*

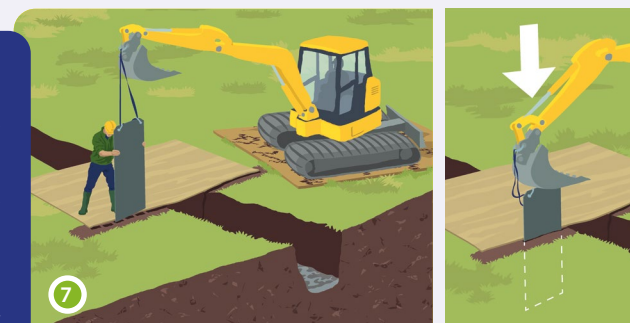
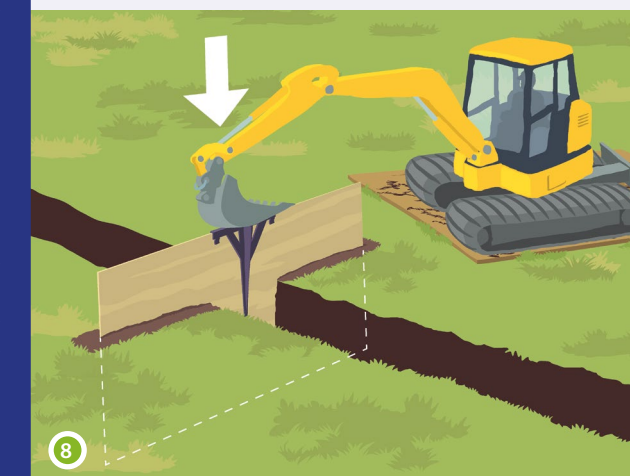
*Succession of solid wood panels used to stop the water vertically and horizontally*

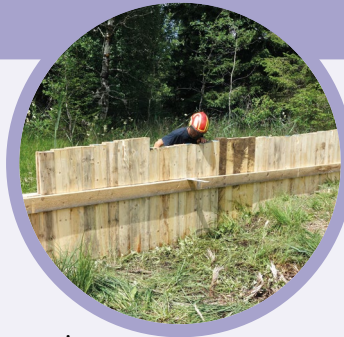
► **Principle:** comparable to the previous point, this type of fence allows a draining point of flow (ditch, old peat extraction pit) to be neutralised, but it is applied to larger openings (wide or deep ditches) requiring deeper anchoring or needing to resist greater hydraulic loads. The structures installed have to be sufficient in number and close enough together, in view of the up/downstream and lateral topography (left bank/right bank) to effectively block the flow of water.

► **Characteristics:** these fences consist of solid untreated timber planks 16 to 20 cm wide and at least 10 cm thick, tongue-and-grooved, bevelled at the base <sup>13</sup>. The species used in the Life programme is spruce, the local timber, which offers a good cost-effectiveness ratio.

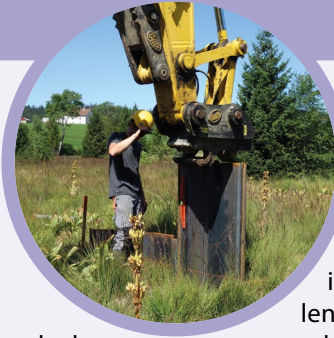
► **Principle:** in a similar way to timber plank fencing, steel sheet piles can be used to obliterate large draining features (large ditches or extraction pits). They were preferred for their better resistance, better anchoring in the mineral substrate or to allow an underlying flow.

► **Characteristics:** they consist of bare steel sheet piles connected to one another by slotting into U-channels, guaranteeing a solid installation of the structure. The sheet piles are not welded together.

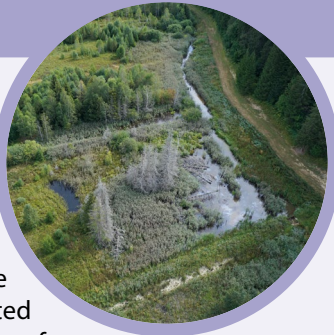
► **Principle:** many of the Jura peatlands were created as a result of the presence of a moraine bar. The reconstitution of similar contexts has been tested downstream of peatland complexes.

► **Characteristics:** a dyke consisting of mineral material, clay or morainal material with a high proportion of clay. The dyke is placed directly on top of the enclosing mineral substrate, after excavation of the covering topsoil (residual peat, very highly mineralised).

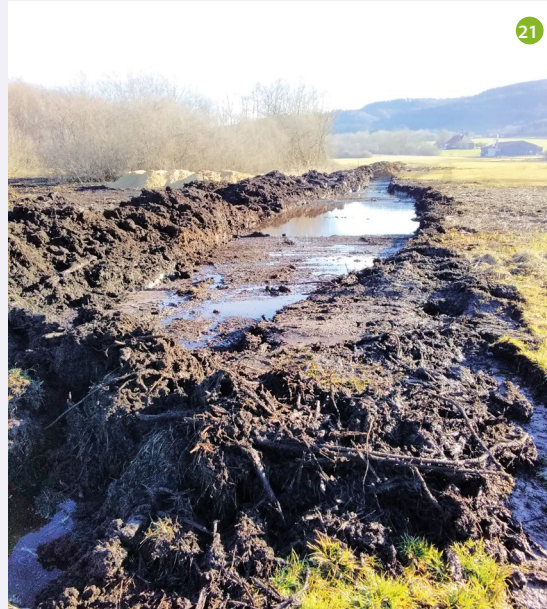
- a Excavation of a trench in the peat to expose the mineral substrate enclosing the width of the dyke to be created **21**.
- b Morainal materials placed directly on top of the mineral substrate to create a trapezoid dyke **22**.
- c Covering with excavated material so that the vegetation can take hold again and for better integration into the landscape **23**.

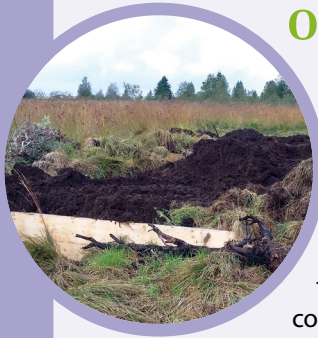
► **Principle:** when the drainage ditch has a substantial slope or the area immediately around the ditches is too mineralised, a succession of “reaches” of water will do little to achieve the required rewetting of the peatland. It is then necessary to completely fill in the ditch the draining impact of which is to be reduced.

► **Characteristics:** the nature of the materials used will depend on a combination of several factors: characteristics of the peat, ease of bringing in materials, possibility of obtaining them on the site, etc.

► **Context of use and installation:** Whatever the context of the installation, it is always necessary to clear out the ditch first, so as to “clean” the edges, removing any heterogeneous vegetation or severely damaged, porous peat. This limits the phenomena of preferential flows in contact with the materials in place and those used for the infilling. The residue that is cleared out will be re-used to cover the structure, and to encourage the vegetation to resume growing.

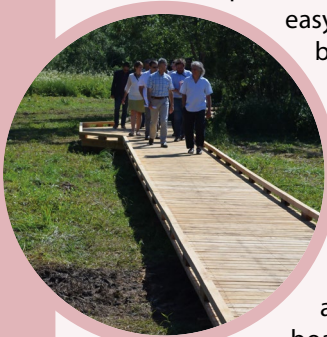
- **Characteristics and installation techniques:** the purpose of this type of boardwalk is to provide easy access to the general public. It can be adapted to allow access for people with reduced mobility (creation of passing places, access ramps, adaptation of the furniture, signage, etc.).

The first step consists of preparing the route by cutting and clearing the area where the boardwalk will go. The foundations of the structure are then created by driving posts into the ground as far as the mineral substrate, or at least to a depth of 200 cm **1** **2**. The minimum section that contractors under the programme were required to use for these stakes was 120 x 120 mm. The decking planks are fastened on joists (minimum 60 x 140 mm), which are themselves fastened

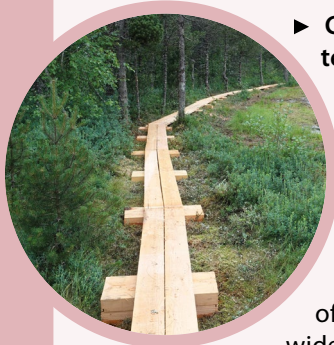
► **Characteristics and installation techniques:** a lighter installation than the previous one, this rustic boardwalk is intended for hikers and is not suited to pushchairs or people with reduced mobility.

The paths consist of a double line of boards laid lengthways, 20 cm wide each, in the direction of walking, spaced to allow comfortable walking: about 1 to 2 cm apart **7**. These boards are screwed or nailed onto sufficiently wide cross planks. The planks are placed directly on the peat, level with it, which means removing the surface vegetation in some places or a little manual banking up. It was chosen to use a span of 150 cm between the planks, but these should be adapted to the microtopography and changes of direction, where necessary. In some cases, the planks may be fastened to posts driven into the ground (about 1.5 m) in any sections liable to be flooded and therefore create a risk of floating **8**.
