Life Réhabilitation fonctionnelle des tourbières  
du massif jurassien franc-comtois  
LIFE13 NAT/FR/762 - 2014 / 2021

# Collection of experiences

## Functional restoration of peatlands in the Jura massif

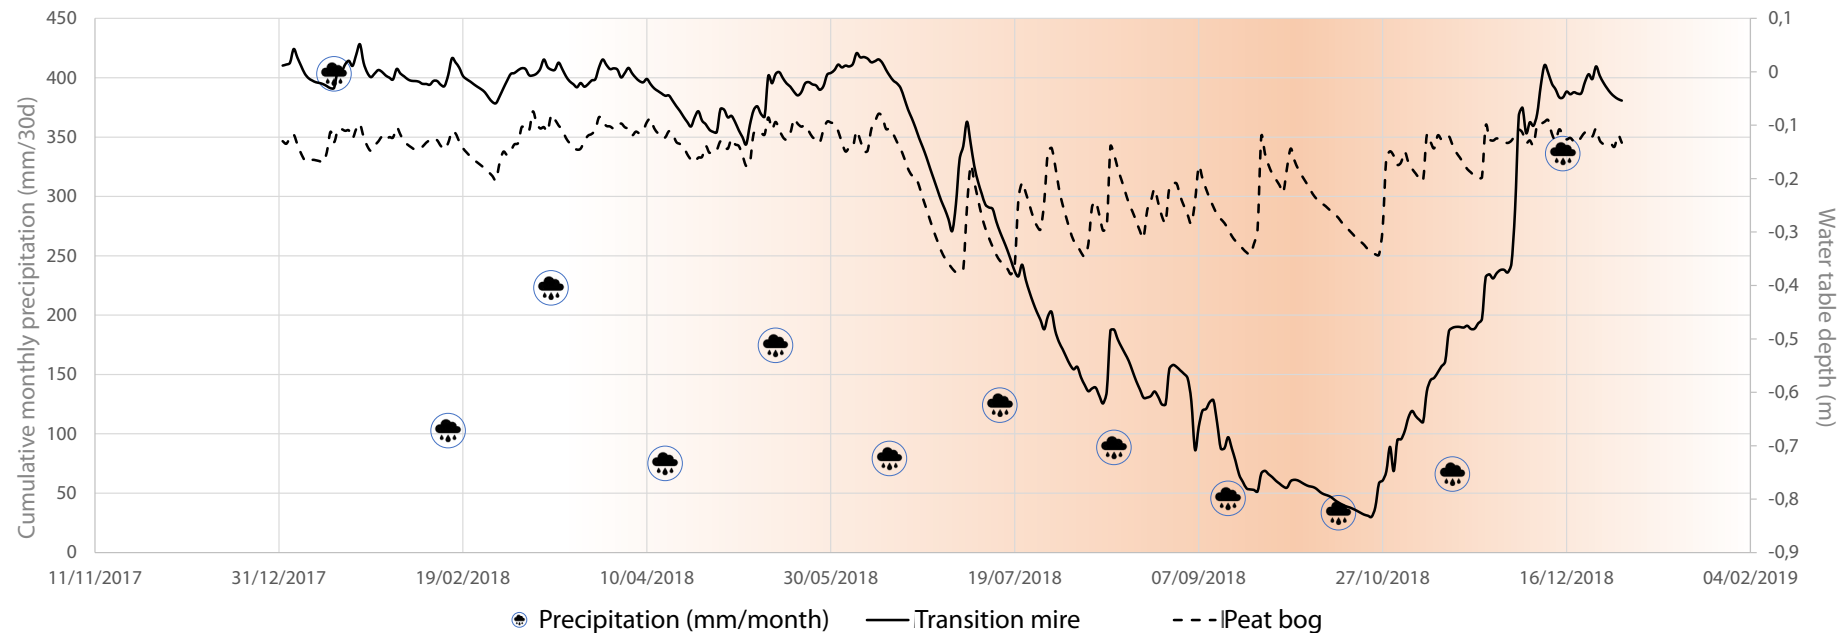
<sup>7</sup> Changes in the depth of the water table in the body of peat of two bogs during one water year
